EFFECTS OF BEAVER ON STREAM TEMPERATURE IN A YOUNG RESTORATION SITE

Lisa Hainey
Upper Skagit Indian Tribe
319-106 Tribal WQ Workshop
April 24, 2018

HANSEN CREEK RESTORATION PROJECT

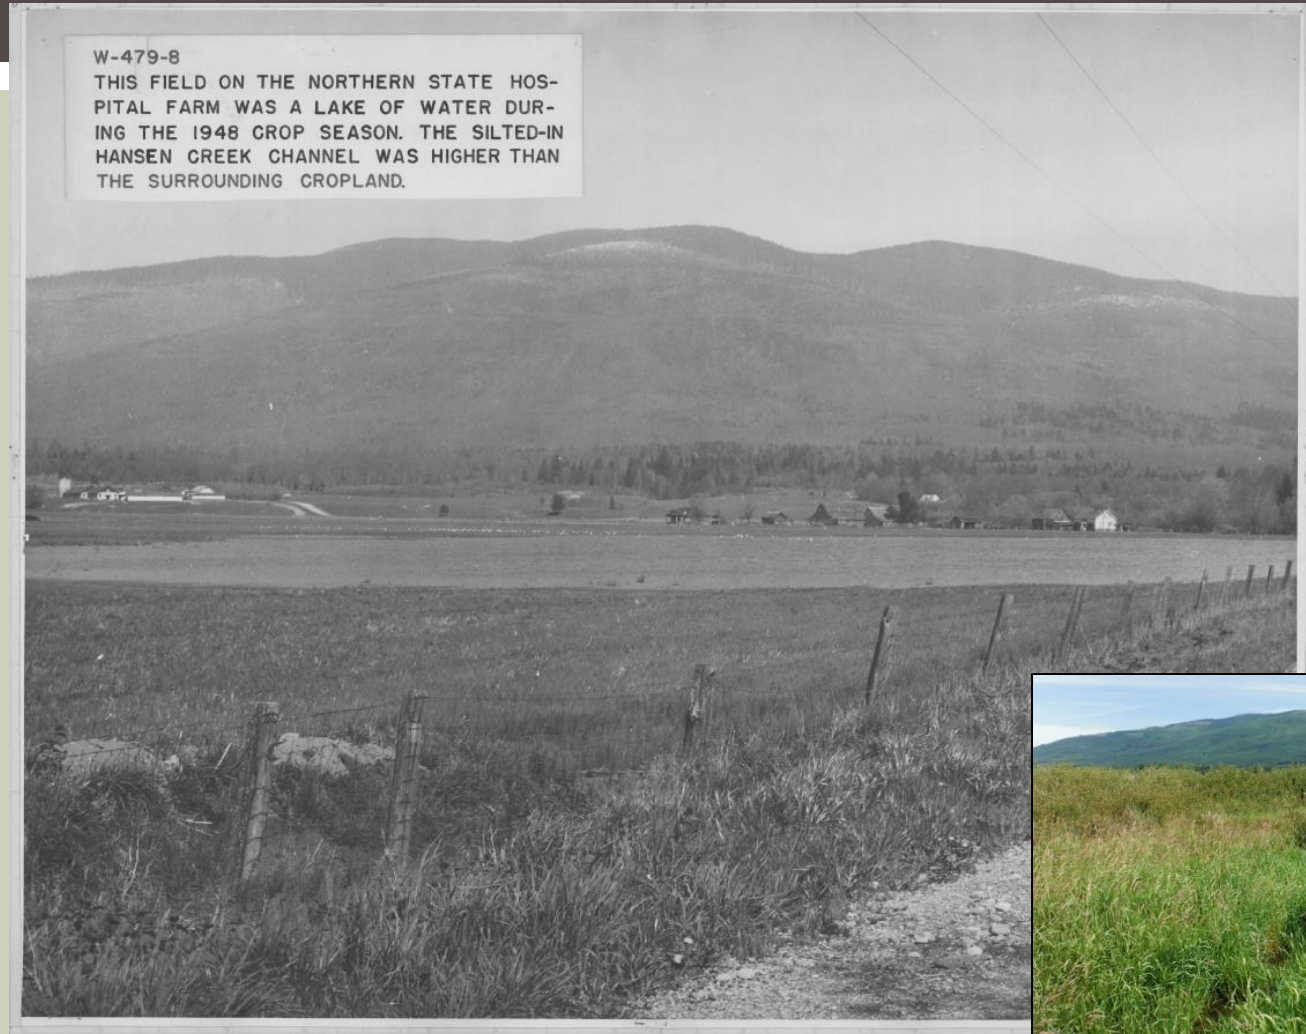
Northern State Hospital agricultural fields
1948 photo of low land flooding on Hansen Creek

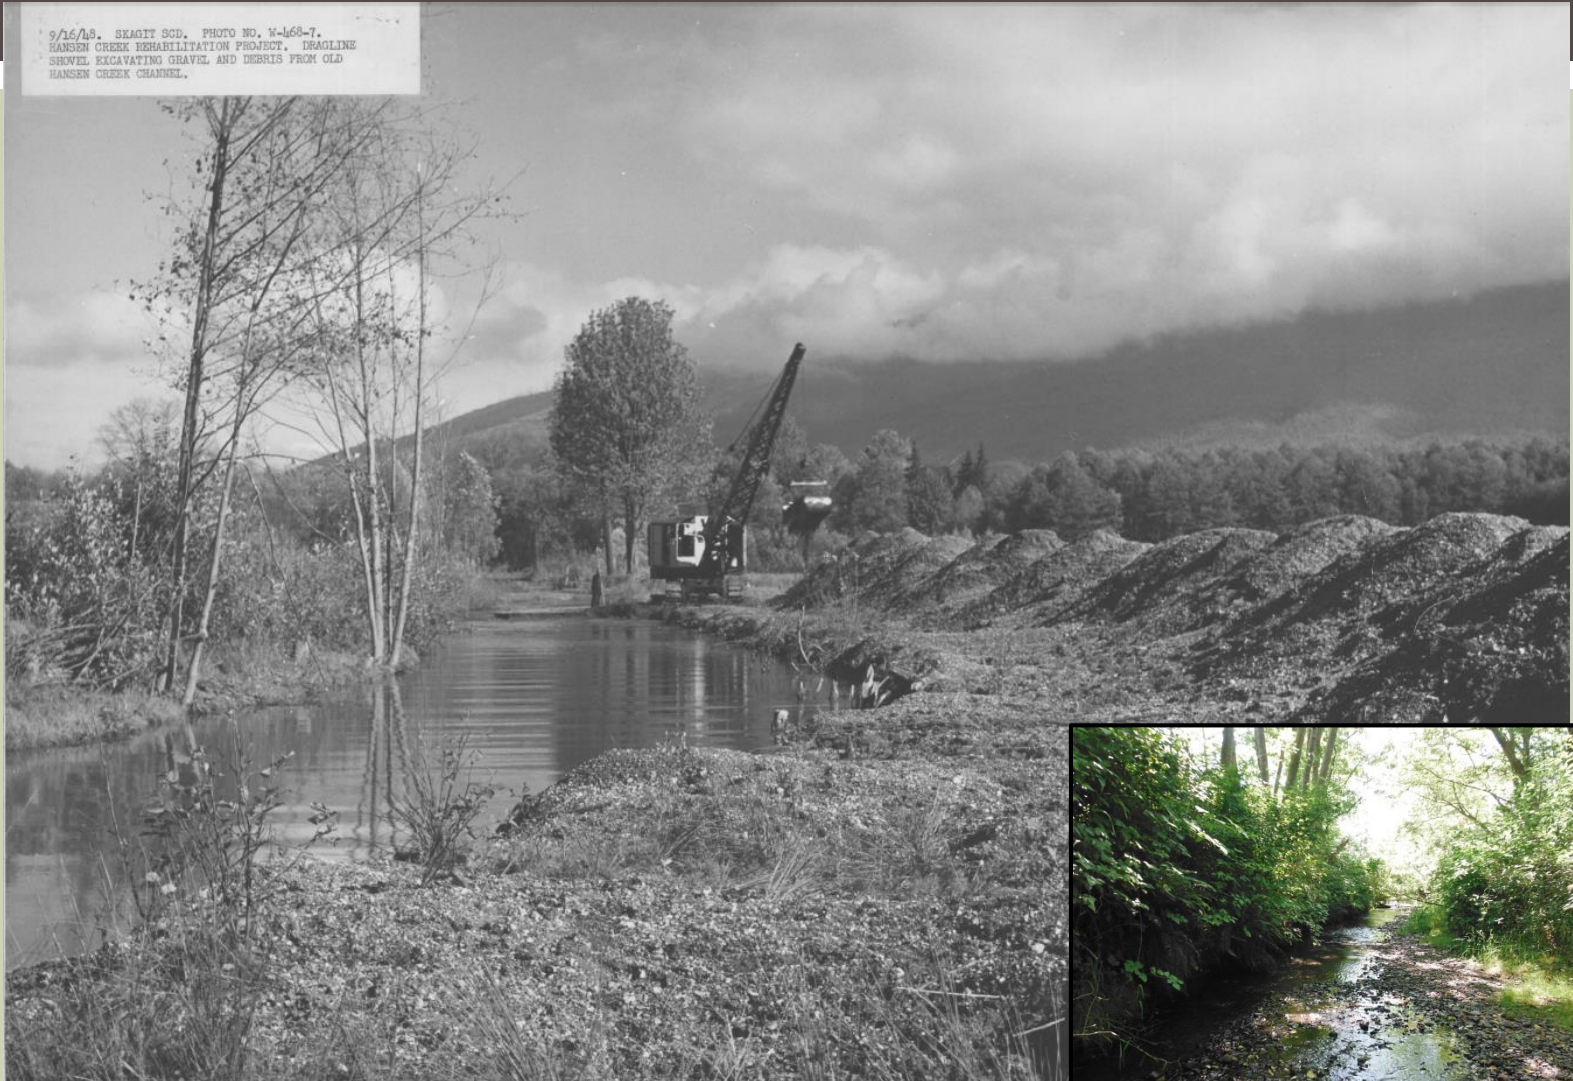
1948 – First Recorded Dredging of Hansen Creek

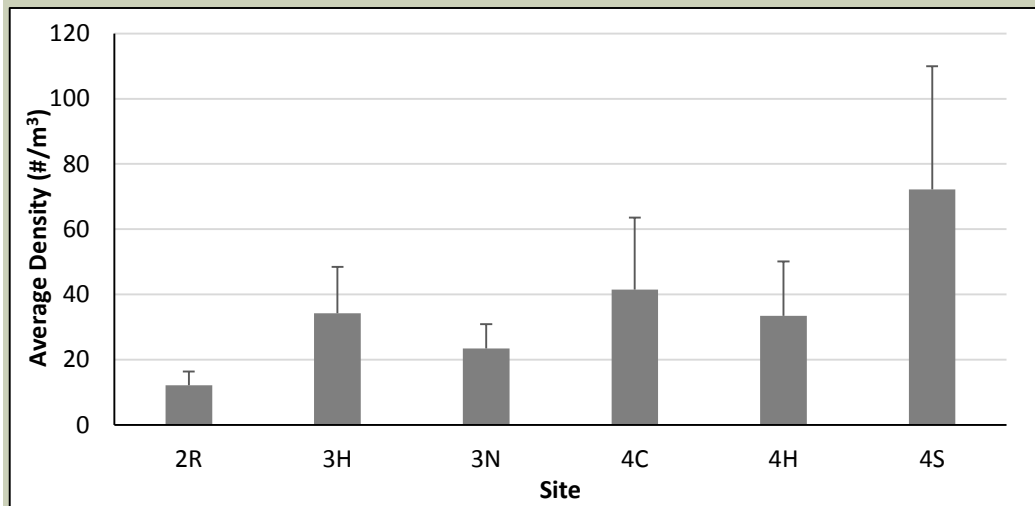
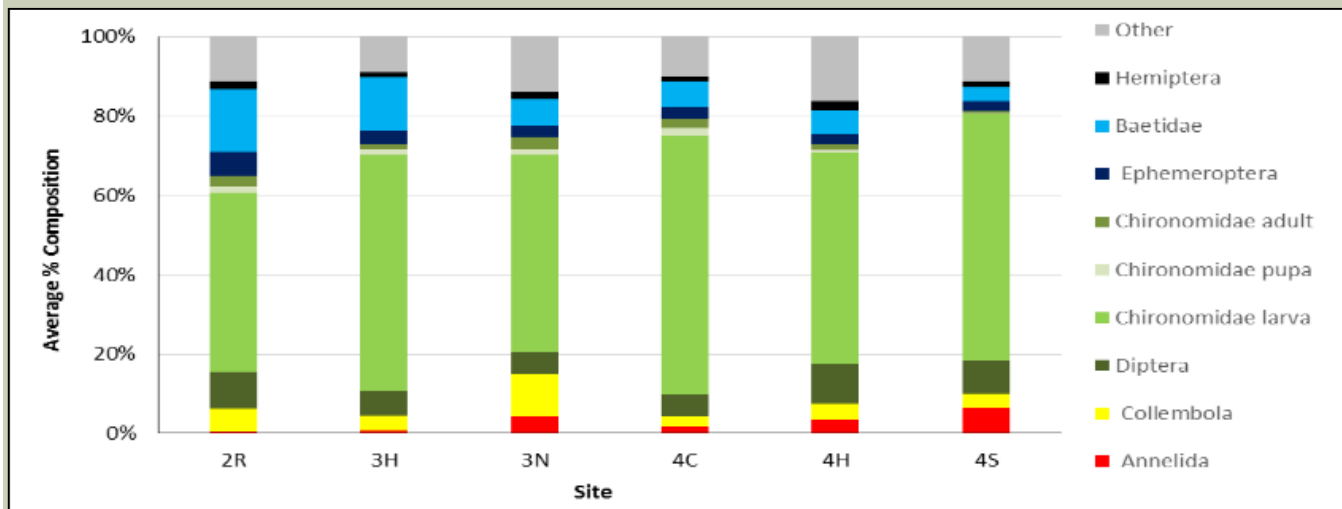
JUVENILE SALMONIDS: PREY RESOURCES

All reaches are similar in prey density and composition.

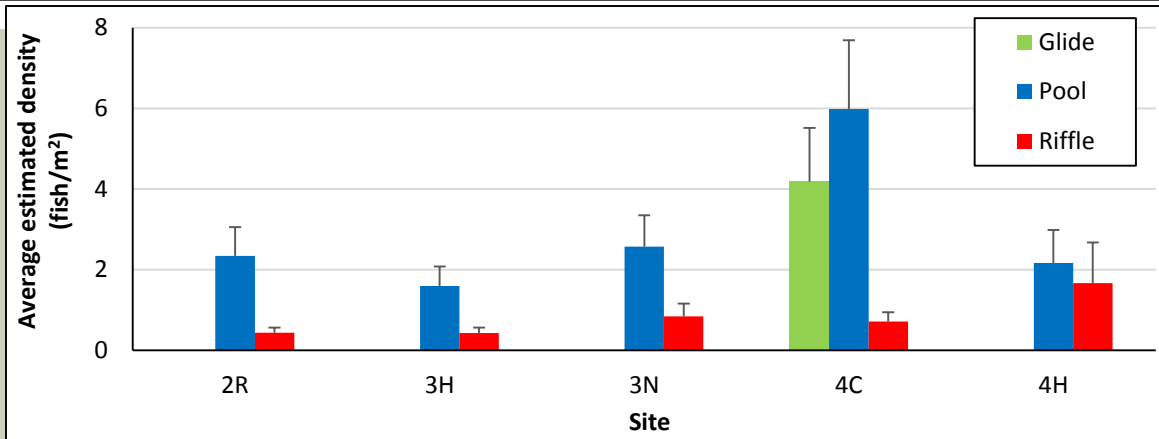
JUVENILE SALMONIDS: COHO DENSITY/ABUNDANCE

Coho densities follow expected patterns across the project.

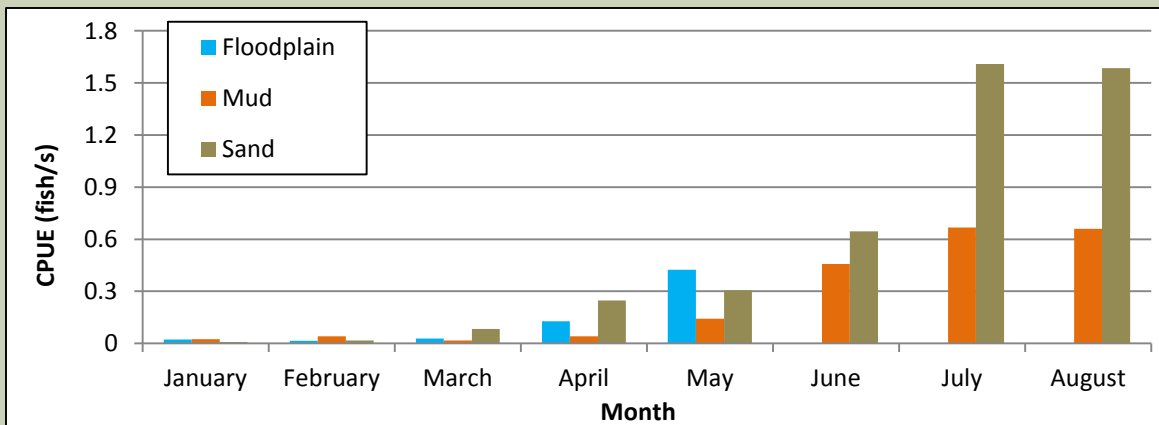
Coho can access floodplain & wetland capacity.

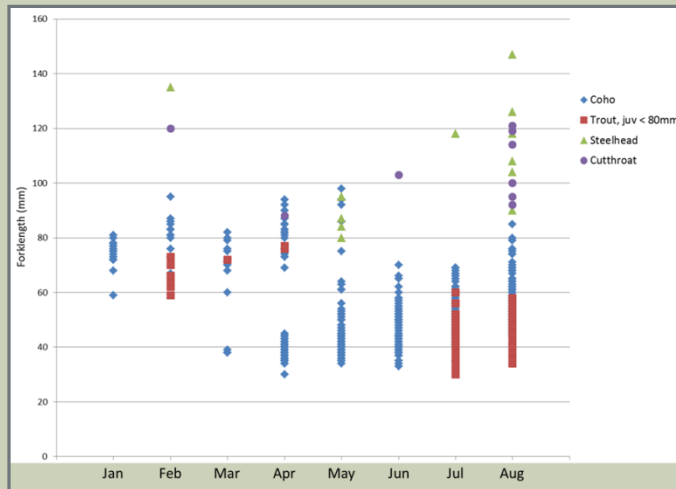
Fork length
of salmonids
captured by
netting

- Coho used inundated areas during high flows and fish caught there had higher instantaneous ratios than all other fish of equal sizing.
- Few trout were caught, though they were observed in snorkel survey
- Diet composition varied by location and date sampled
